Vibration	Contact Vibration of Rotor due to Growth of Carbide in Bearing	Rotating machinery
Forced Vibration

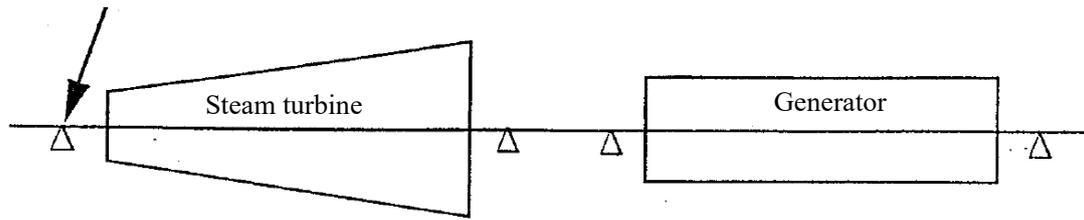
Fig.1 General arrangement of shaft system

Object Machine	Power generation turbine for industrial use (general arrangement shown in Fig.1), 42MW, 3,600rpm
Observed Phenomena	Vibration component synchronized with the rotational speed increases for some reason, but after a short time, returns to the former condition and again increases. This phenomenon occurred repetitively. Fig.2 shows the shaft vibrations of this machine.
Cause Estimation	Judging from the fact that the vibration component corresponds to the rotational speed and that the growth of vibration is not so sharp, it was determined that the shaft was in slight contact with the casing.
Analysis and Data Processing	No special analysis was not carried out. When the vibrations became large, a listening rod was used to go around to check sounds of the casing at many locations, and it was estimated that there was a high possibility of a rotor contact near the turbine free end side, but the exact position was not identified.

Countermeasures and Results	After shutting down the turbine, the contact position was checked. Then, on the mating face of the bearing, the growth of carbide that was assumedly due to lubrication oil was found. And then the carbide was removed. As a result the contact vibrations were eliminated.
Lesson	There are pretty many examples that, inside the bearings, carbide grow, leading to contact with a rotor. In these cases, next points are needed to care. (1) Design shall be made so as to avoid becoming a high bearing temperature. (2) Arrangement shall be made to prevent the entry of a dust inclusion in the lubrication oil. In particular, control shall not be neglected at the time of flushing.
References	Nothing in particular.
Keywords	Contact vibration, growth of carbide in the bearings

Bearing where contact occurred
