Case History	Blower Impeller Vibration Caused by Blade-Vane Interaction	Rotating machinery
Resonance

Object Machine Single-stage turbo blower
2,000 kW, 6,900 min⁻¹, steam turbine driven, speed control range (5,300 to 6,900 min⁻¹)

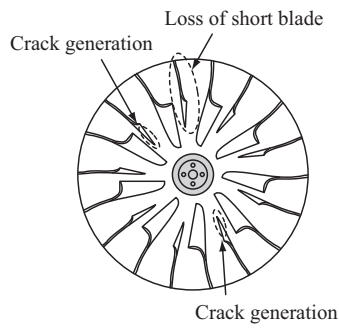
Observed Phenomena A blower trip occurred due to excessive rotor vibration when seven years passed after commencement of operation of the blower. As a result of overhaul, it was found that one impeller was broken and other two had cracks (refer to Fig.1).

Fig.1: Condition of defects and cracks Fig.2: Cross section view of blower

Countermeasures and Results As an emergency countermeasure, the operation procedure was arranged so as to avoid the rotational speed causing resonance, while as a permanent countermeasure, the IGV was removed and only the rotational speed control was employed.

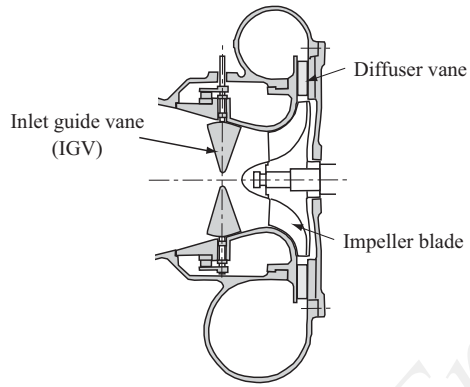
Cause Presumed After checking the operating conditions, it has become clear that the operation speed was gradually increased due to facility expansion since about two years ago. Measurement of the natural frequency of the impeller blades exhibited no sign of the occurrence of resonance. Considering the fact that cracks developed simultaneously at three positions out of the 18 impeller blades, and that this blower had an inlet guide vane (hereinafter referred to as IGV) in front of the impellers, it was estimated that blade-vane interaction due to interference with this IGV was the cause (refer to Fig.2).

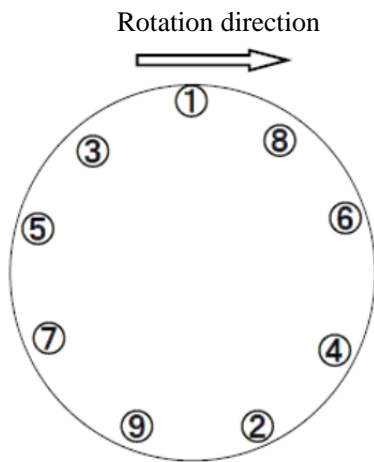
Fig.3: Order of periodic fluctuating loads

Analysis and Data Processing Based on an FEM analysis, a natural frequency analysis and a frequency response analysis were conducted. The calculation included periodic fluctuating loads that were set with a relative phase difference between the impeller and IGV (refer to Fig.3). Modes to generate resonance from among natural frequencies can be determined using the following equation (refer to Fig.4):

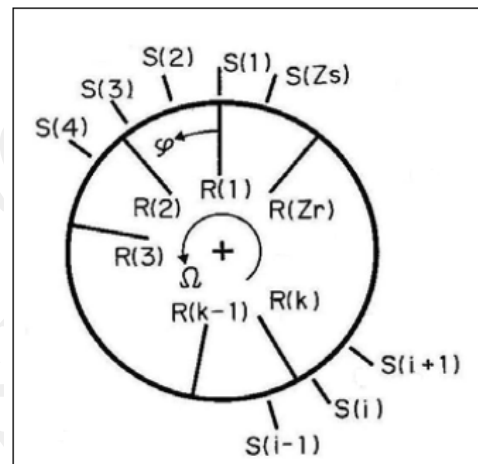
Fig.4: Chart illustrating the criterion formula of blade-vane interaction

$$n \cdot Z_s \pm k = m \cdot Z_r$$

Zs: number of stator vanes, Zr: number of rotor blades, n: order of the rotating system excitation, k: number of nodal diameters, m: order of the stationary system excitation

Impeller's natural frequency: 1,215 Hz

Impeller's rotational speed: 6,627 min⁻¹

$$n \cdot Z_s \pm k = m \cdot Z_r \rightarrow 1 \cdot 11 - 2 = 1 \cdot 9$$

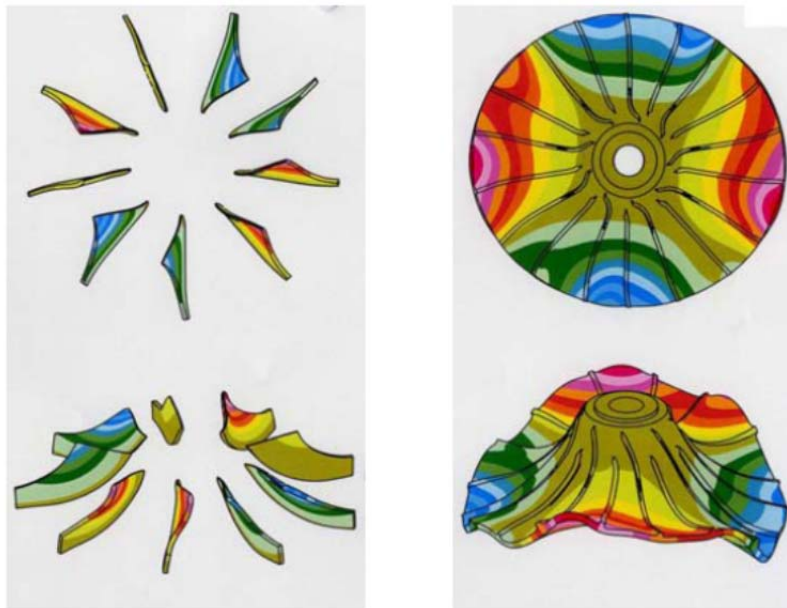
Results of the frequency response analysis verified that large deformations took place on the impeller blades where defects and cracks developed in the above vibration mode (refer to Fig.5).

Fig.5: Deformation of blade and impeller when resonating
