Case History	Abnormal Vibration of Gear Reducer	General machine
Forced

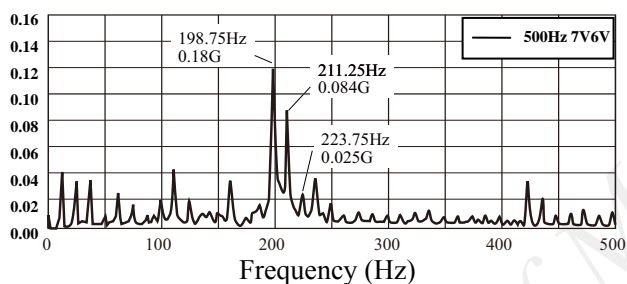
Fig.3: Frequency analysis of acceleration (Hz)

Object Machine	Gear reducer for motor driven fan
Observed Phenomena	A monitoring accelerometer mounted on the gear reducer indicated an alarm level vibration value.
Cause Presumed	It was estimated that the problem was specific to this gear (tooth contact, pitch error, tooth damage, etc.) as the models of the same type experienced no such problem.
Analysis and Data Processing	<p>Time history analysis, frequency analysis and envelope analysis of the measured vibration data were performed as follows:</p> <ul style="list-style-type: none"> ▪ Time history analysis—Striking phenomenon → Separation of tooth surface ▪ Frequency analysis—Major component being due to tooth meshing on the second stage → Second stage gear ▪ Envelope analysis—Rotational component of gear intermediate shaft → Second stage gear on the intermediate shaft side <p>In addition, a hammering test confirmed no resonance.</p> <p>Then, as a result of observation of the tooth surface, a slight indentation was detected.</p>

Countermeasures and Results	<p>After replacing the gear intermediate shaft, adjustment was made of the input gear contact, and thus vibration ceased.</p> <p>Checking by the gear manufacture of the gear on the intermediate shaft side second stage proved that the pitch error was more than the reference value.</p>
Lesson Learned	Analysis based on the basics may clarify the defects identified to significant degree.
References	Nothing in particular
Keyword	Pitch error, envelope analysis, AM modulation
