Vibration	Excessive Vibration due to Cavitation of Pit Barrel Type Vertical Mixed Flow Pump	Rotating Machinery
Forced Vibration

Pit barrel type vertical mixed flow pump
(diameter 900mm, 590min⁻¹~137.2m³/min~21.5m~670kW)

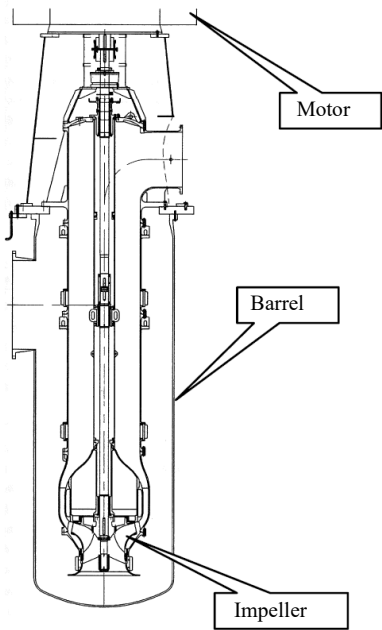
Fig.1 Example of construction of pit barrel type vertical mixed flow pump

At the time of start-up of a multi-stage flush type seawater desalination plant, the pit barrel type vertical mixed flow pump (refer to Fig.1) for the BBDP (Brine Blow Down Pump) delivered to this plant, on the motor top, excessive vibrations exceeding 20(mm/s)rms against the specified value of 4.5(mm/s)rms has been measured. As shown in Fig.2, vibrations suddenly increases when NPSHA went down to about 11m or less during the process of depressurization of the evaporator inside pressure from the atmospheric condition to a specified suction state (NPSHA = 8.9m).

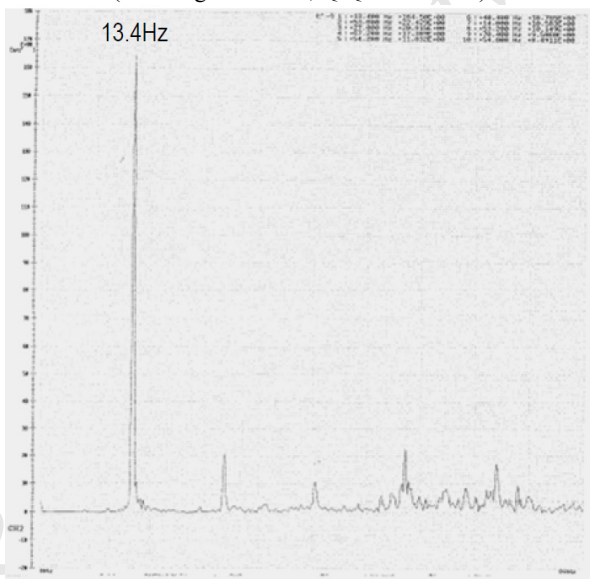
Fig.3 Result of frequency analysis of vibration on the motor top of an actual machine (discharge direction, $Q/Q_{rated} = 110\%$)

It was judged from the following three conditions: the vibration value suddenly changes according to the suction condition; results of frequency analysis of vibrations in Fig.3 indicate that the major component of excessive vibrations is the natural frequency of the motor top; and the vibration value decreases to maximum 6(mm/s)rms, when air was injected from the suction piping at the time of maximum vibrations. It was assumed that the cause of excessive vibrations is that air bubbles has been generated due to cavitation excited the blade surfaces randomly with impulsive force occurring when they collapse.

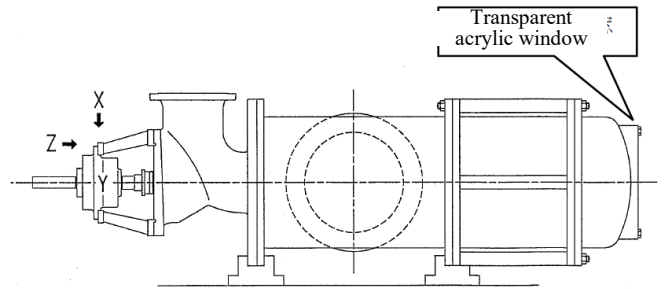
Fig.4 Vibration measurement positions of a model pump

In order to verify the assumed cause, a model pump, 1/4 scale of the prototype (as shown in Fig.4), was fabricated to perform a model test. In this test, the current blades without countermeasures and new blades with modified tip shape for restricting the generation of cavitation were used, and bearing vibrations were determined by changing the pump performance, suction performance and suction condition. In addition, the condition of occurrence of cavitation on the blade surface was observed through a transparent acrylic window provided on the model pump bottom. Fig.5 compares vibration values of different impellers in the model pump before and after taking countermeasures. It is clear from this figure that vibration values of the new impeller were greatly reduced compared to the conventional one without modification. As for the condition of occurrence of cavitation (refer to Fig.6), it was visually confirmed that cloud-like large scale cavitation occurring at the specified NPSHA before taking countermeasures, while in case of the new impeller, only thin sheet cavitation occurring. From these results, it has become clear that the cause of excessive vibrations was cavitation.
