Vibration	Vibration Behavior Associated with Deposited Material Attached to Oil-lubricated Bearing	Rotating Machinery
Forced Vibration

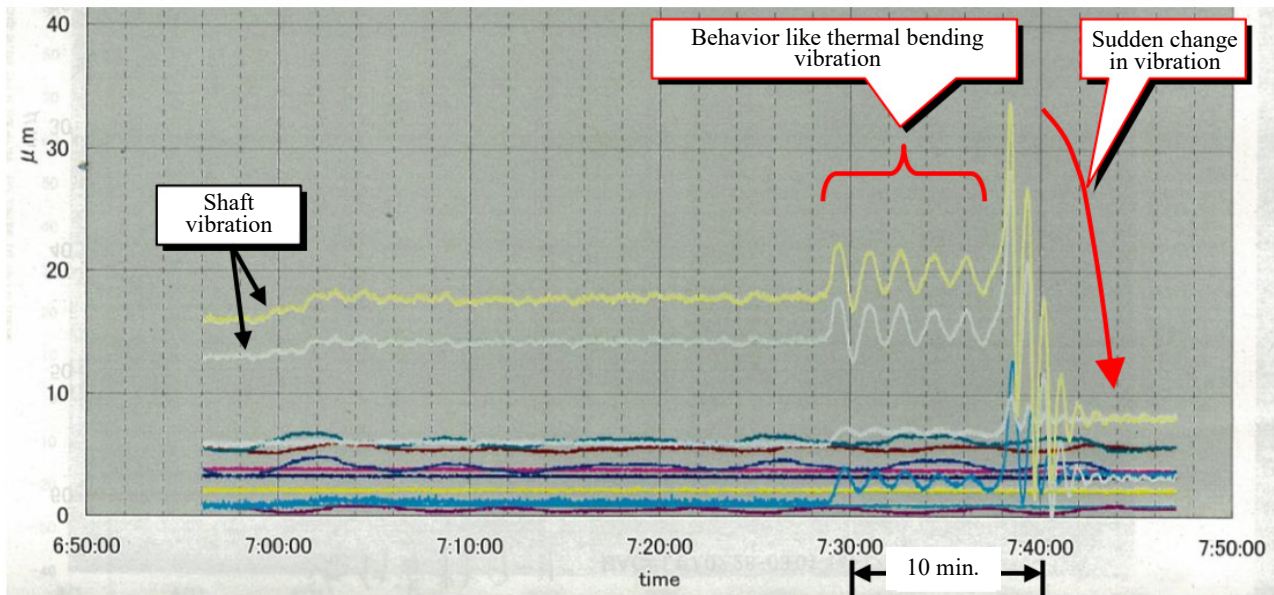
Object Machine	Rotating machinery using tilting-pad journal bearings having high surface pressure (surface pressure 20kgf/cm <sup>2</sup> or more, PV value about 2,000kgf/cm <sup>2</sup> ·m/s)	
Observed Phenomena	Shaft vibration immediately after start-up was about 10μm, but for the subsequent 20 days, it gradually became large, displaying a behavior like thermal bending or abrupt increase and decrease in vibrations, and eventually returned to the original vibration level (Fig.1).	
Cause Estimation	Disassembling inspection proved that, a) the bearing load pad had a deposited material of about 15μm (Fig.2), and b) the stationary part had no trace of contact to cause thermal bending. Thus, the following assumption was made as to the outbreak mechanism of this phenomenon: (1) gradual accumulation of the deposited material on the load pad resulted in changes of oil film characteristics (reduction in damping), leading to gradual increase in vibrations, (2) growth of deposited material exceeding the oil film thickness resulted in contact with the shaft, to generate thermal bending vibrations, and (3) contact of the shaft with the deposited material caused a partial exfoliation of the deposited material, resulting in the recovery of oil film characteristics and sudden decrease of vibrations.

Fig.1 Vibration behavior observed after continuous gradual increase in shaft vibration

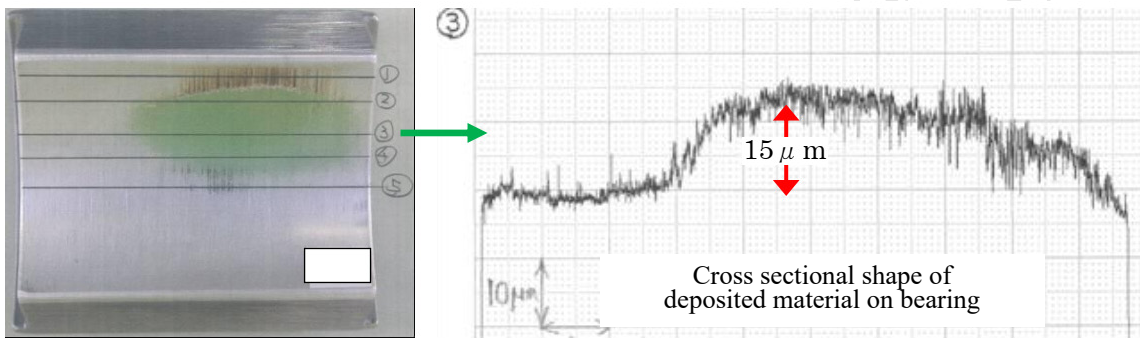
Analysis and Data Processing	Chemical analysis of the deposited material proved that deteriorated oil was exposed to high temperature to combine with copper, to form metal soap. Copper assumedly melted in oil from the heat exchanger, but it was only a small amount, so that high temperature of the bearing face was assumed to be the root cause, and thus bearing temperature was analyzed (Fig.3). On an assumption that the rotor under question bent in the center due to the bearing load, and the shaft was in an inclined condition within the bearing (about 0.5% as calculated from the load), the following was verified: a) the maximum bearing temperature was about 130 to 140°C, and b) the high temperature area was inclined to the thinner side of the oil film, which agrees well with the area of deposition. From the above, it was determined that the shaft inclination (rotor bending) was the cause of high temperature of the bearing face.

Fig. 2 Deposited material on bearing (copper content exhibits green)

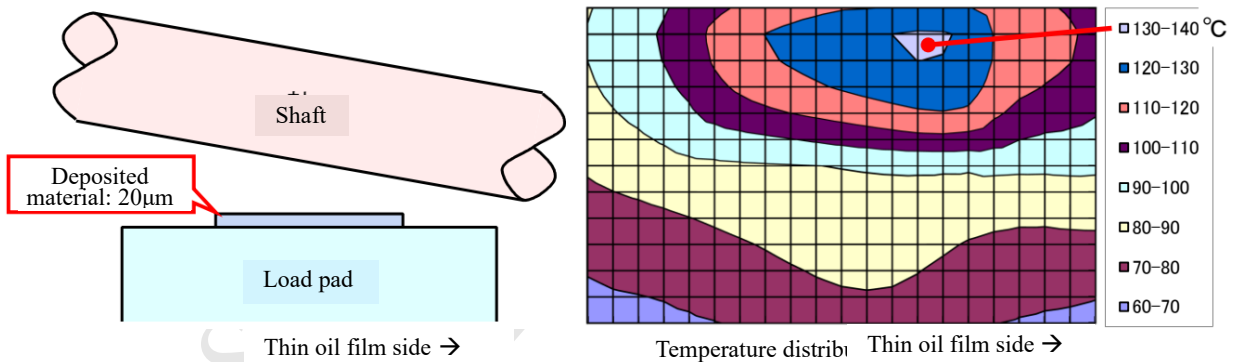
Fig.3 Analysis of bearing temperature (in case of deposited material: 20 micrometers)
