2012 INTERNATIONAL ISOE ALARA SYMPOSIUM

Lessons of Fukushima-Daiichi NPP's Accidents for Achievement of the 1st Class Safety in the World

Dr. Tadashi NARABAYASHI
Nuclear and Environmental Systems
Hokkaido University

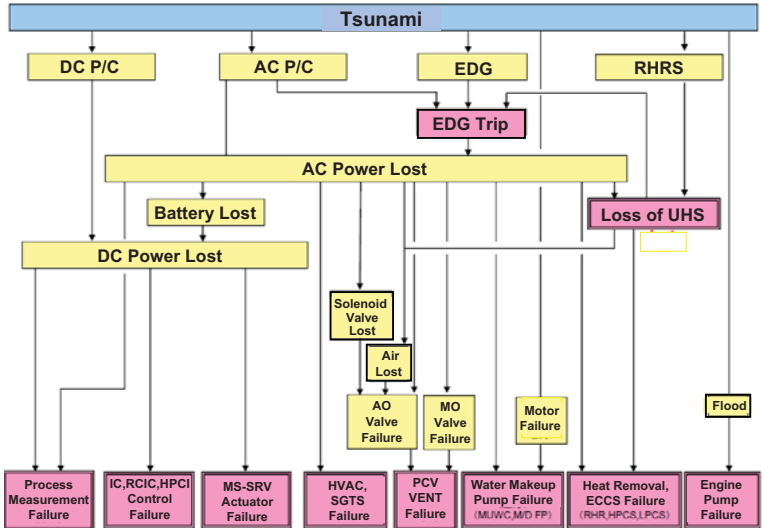
SBO in Fukushima Daiichi NPPs

#1	#2	#3	#4	#5	#6
DG	A:NG B:NG (T/B B1)	A:NG (B1) B:OK (FP/B 1F)	A:NG B:NG (T/B B1)	A:NG (T/B B1) B:OK (FP/B 1F)	A:OK->NG B:OK->NG (T/B B1) Water Cooling	A:OK->NG (R/B B1) Water Cooling B:OK (DG/B 1F)
Metal-Crad Swich	NG (T/B B1)	NG (T/B B1)	NG (T/B B1)	NG (T/B B1)	NG (T/B B1)	Barely (R/B B2F)
Power Center	NG (T/B B1)	Barely (T/B B1)	NG (T/B B1)	Barely (T/B 1F)	Barely (T/B 2F)	Barely (R/B B2F)
DC Buttery	NG (C/B B1)	NG (C/B B1)	OK (T/B BM1)	NG (C/B B1)	OK (T/B BM1)	OK (T/B BM1)
ECCS RCIC	HPCI:NG IC:OK(FC)	NG RCIC:OK	HPCI:OK RCIC:OK	(No Fuels in RPV)	–	HPCS:OK (R/B B1)

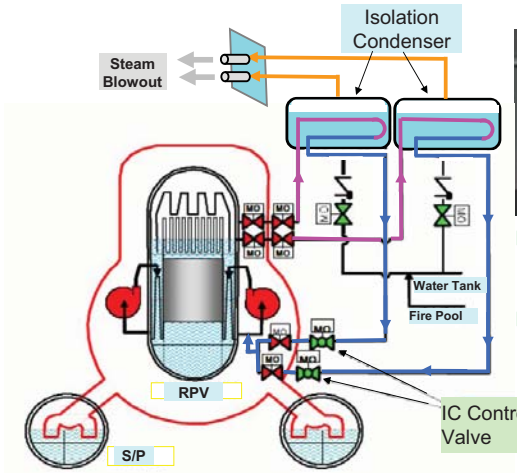
ICs in unit #1 were tripped by FC

- Loss of battery power for main control room caused the fail-close action to MO isolation valves to stop the IC. It was a fail-dangerous system.
- If the IC continue to operate, the accident would be terminated soon.

- RCIC steam turbine also stopped by loss of battery power in Unit #2 and #3.
- S/P temperature and pressure were so high that AM water injection took a lot of times.

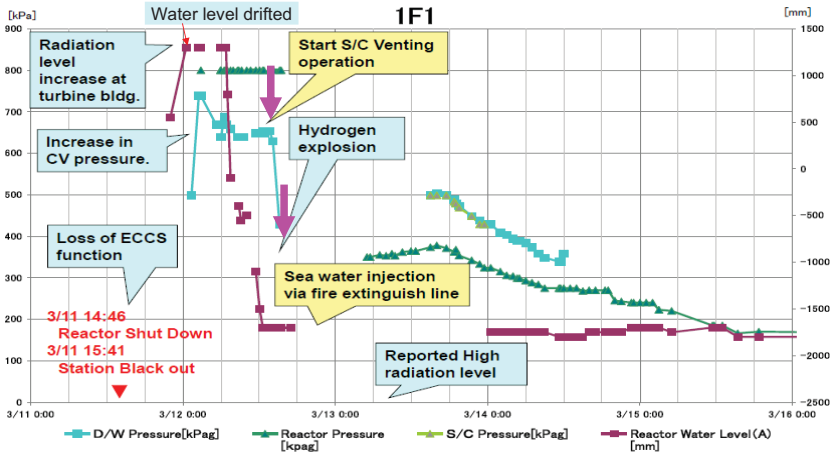
CV Pressure Trend in unit #1

- After loss of ECCS and IC core cooling, CV pressure increased.
- Water level drifted by vaporizing water in reference leg.
- Radiation level increased at T/B.
- Hydrogen explosion occurred after S/C wet venting.

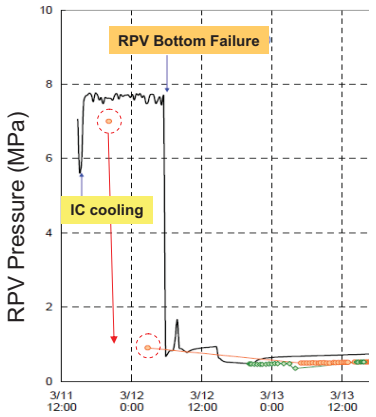
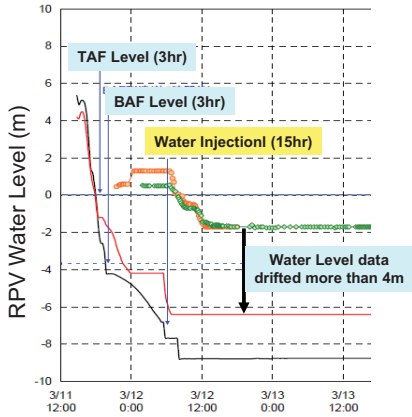
Pressure and Water Level in #1 RPV

- Analysis results show the RPV depressurization started before RPV bottom failure. It might be caused through melted TIP tubes in the core.
- Water level measurement was drifted by the loss of water in a reference leg by high-temperature superheated core.

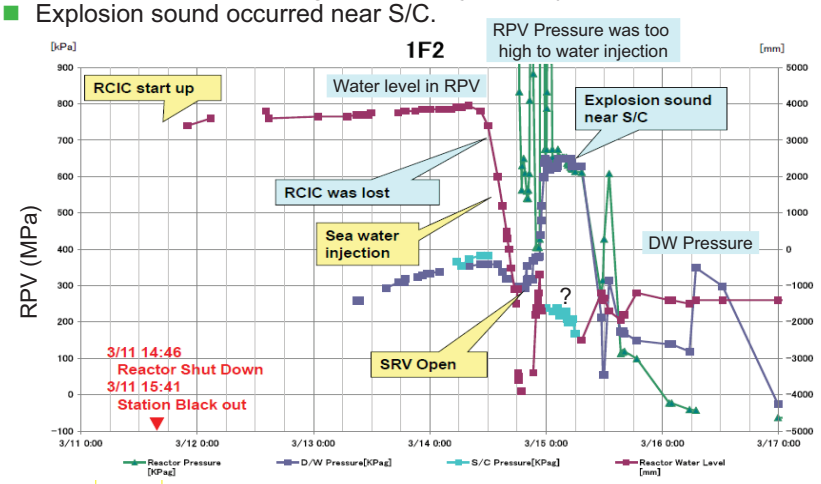
CV Pressure Trend in unit #2

- After loss of RCIC water injection, DW pressure increased.
- Water level was decreased after RCIC tripped.
- RPV pressure was too high to water injection by Fire pump.
- Explosion sound occurred near S/C.

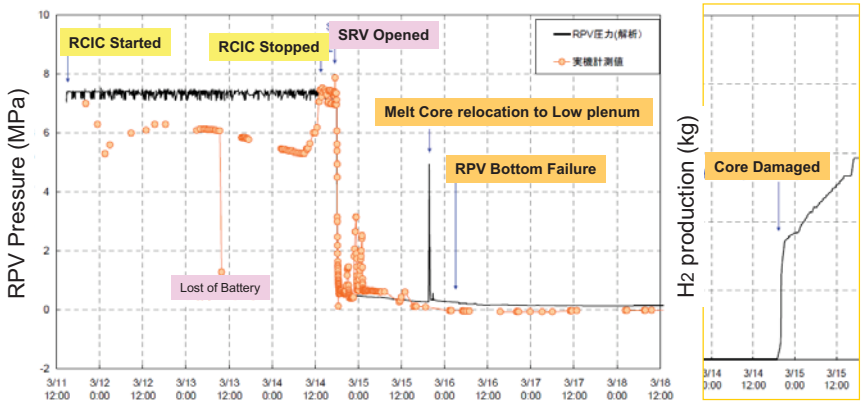
Unit #2 RPV Pressure Trend

Failure of prompt water injection in #2

- Failure of prompt water injection after RCIC stopped in unit #2 caused the core damage and H_2 generation started.
- High-pressure discharge pump driven by diesel engine should be used.

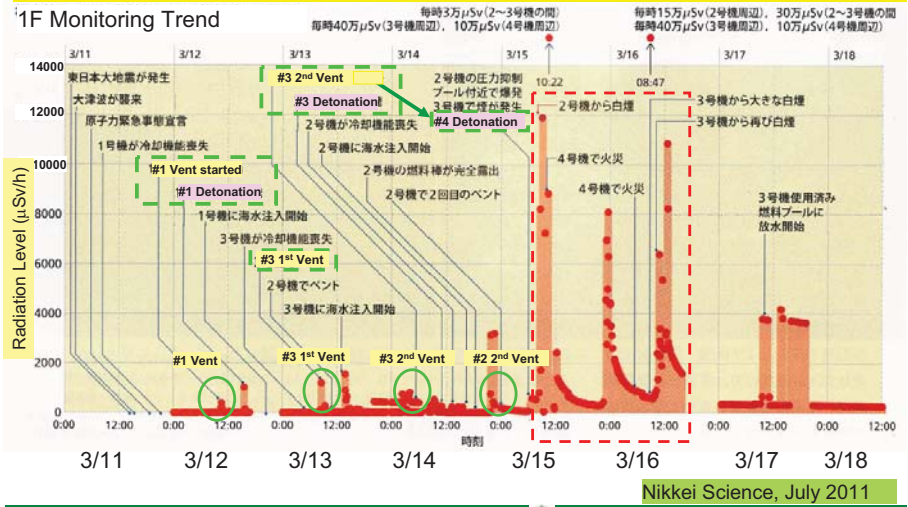
Radiation level increased after CV rapture

- H2 detonation were occurred after vent operation (#1, #3, #4)
- Radiation level increased soon after #2 CV rapture

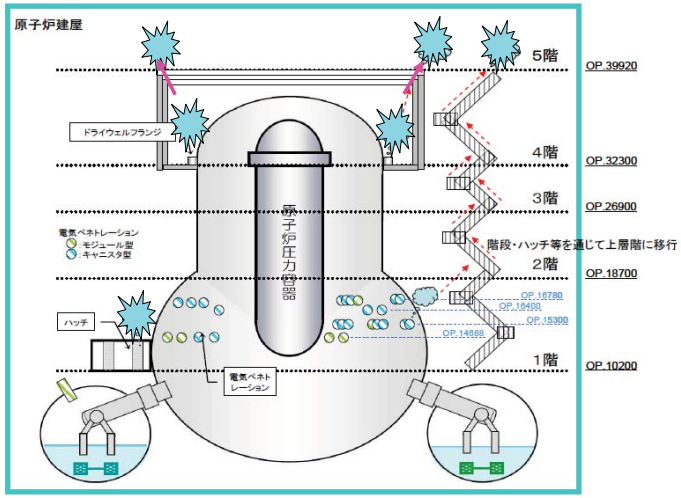
H2 Leak Path from CV

- CV top flange and hatches might be leak pass

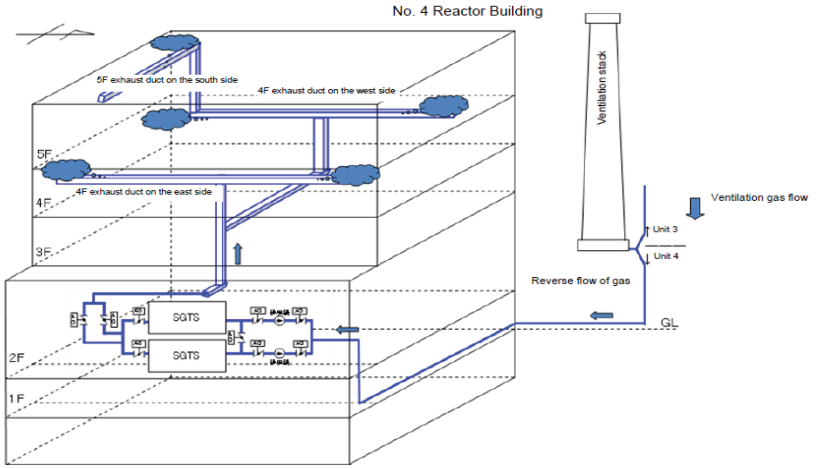
Cause of H2 Detonation in #4 R/B

- #4 was in outage. No fuels in the core
- Hydrogen from #3 flowed into #4 via SGTS

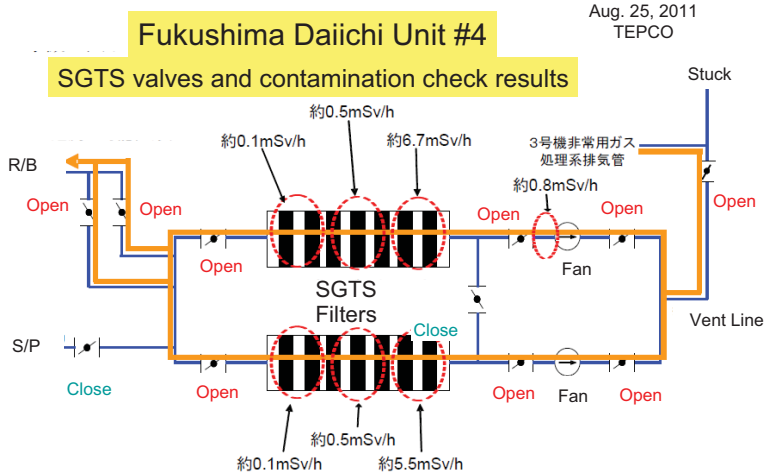
#4's SGTS Filters were contaminated

- Filters in SGTS showed that H2 and FP supplied from #3 flowed into #4 R/B

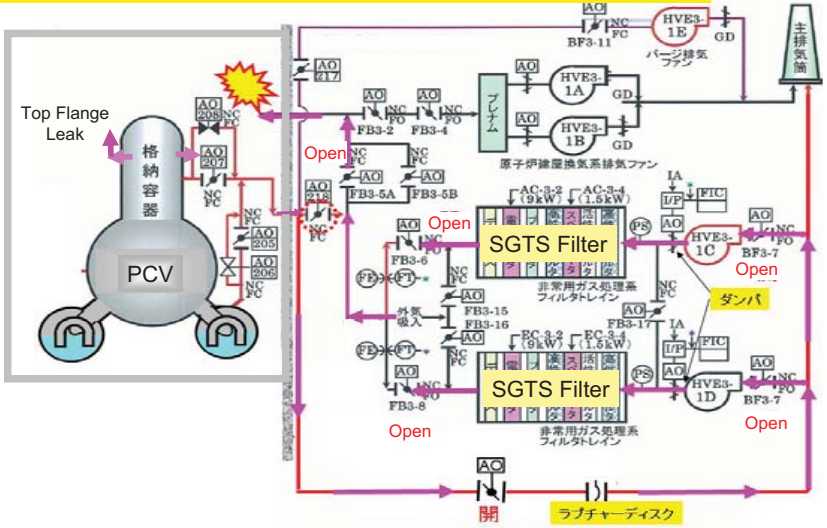
Vent was a cause of suicide bombing ?

Fail-Open valve in SGTS supplied H_2 and FP into R/B
